# BEAR CREEK LAKE DAM

NDI-PA 00545  
PA DER 40-47

PHASE I INSPECTION REPORT  
NATIONAL DAM INSPECTION PROGRAM

MARCH 1979

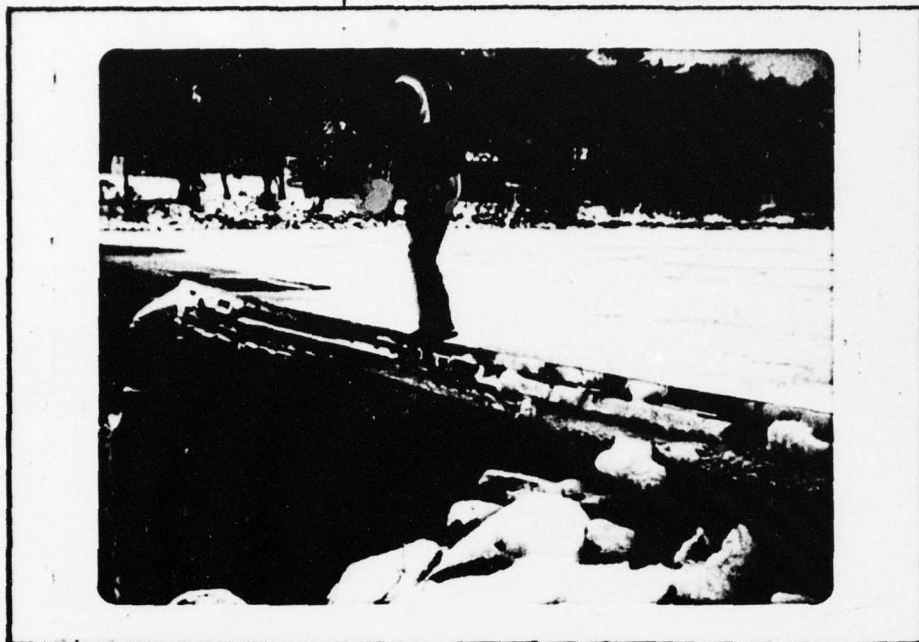
b. Dam. There are many rotten and missing timber members and considerable rock fill is missing from this rock filled timber structure. The earth fill downstream of the weir, on both sides of the weir section has trees growing in it with trunks more than 2 feet in diameter and over 50 feet tall.

*LEFT ABUTMENT SHOWING SOME TIMBER DETERIORATION*

*Replace rotten  
and missing timbers.  
Replace rock in cribbing.*

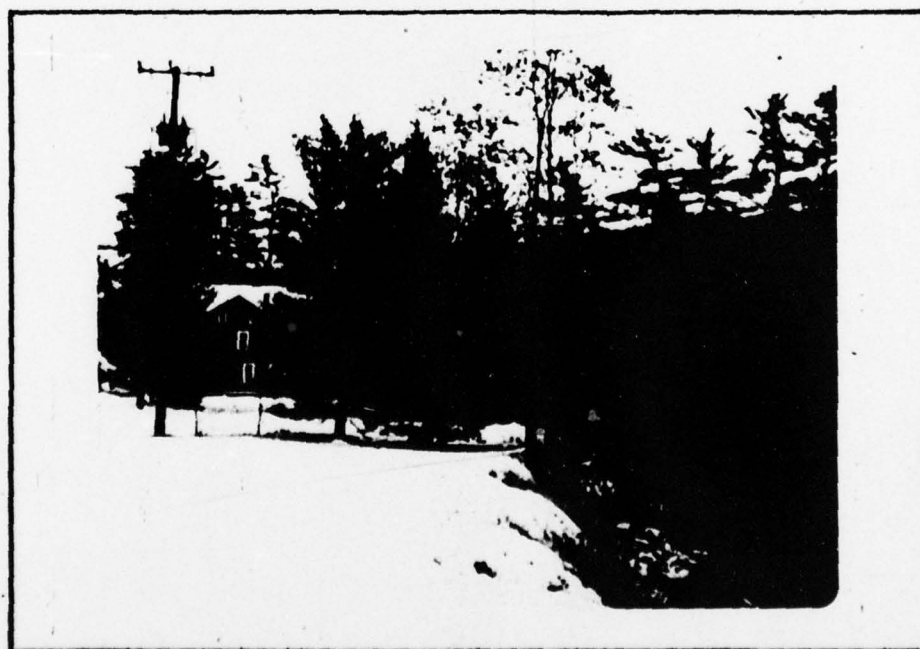
*DAMAGE AREA APPROXIMATELY 600 FEET  
DOWNSTREAM FROM THE DAM*

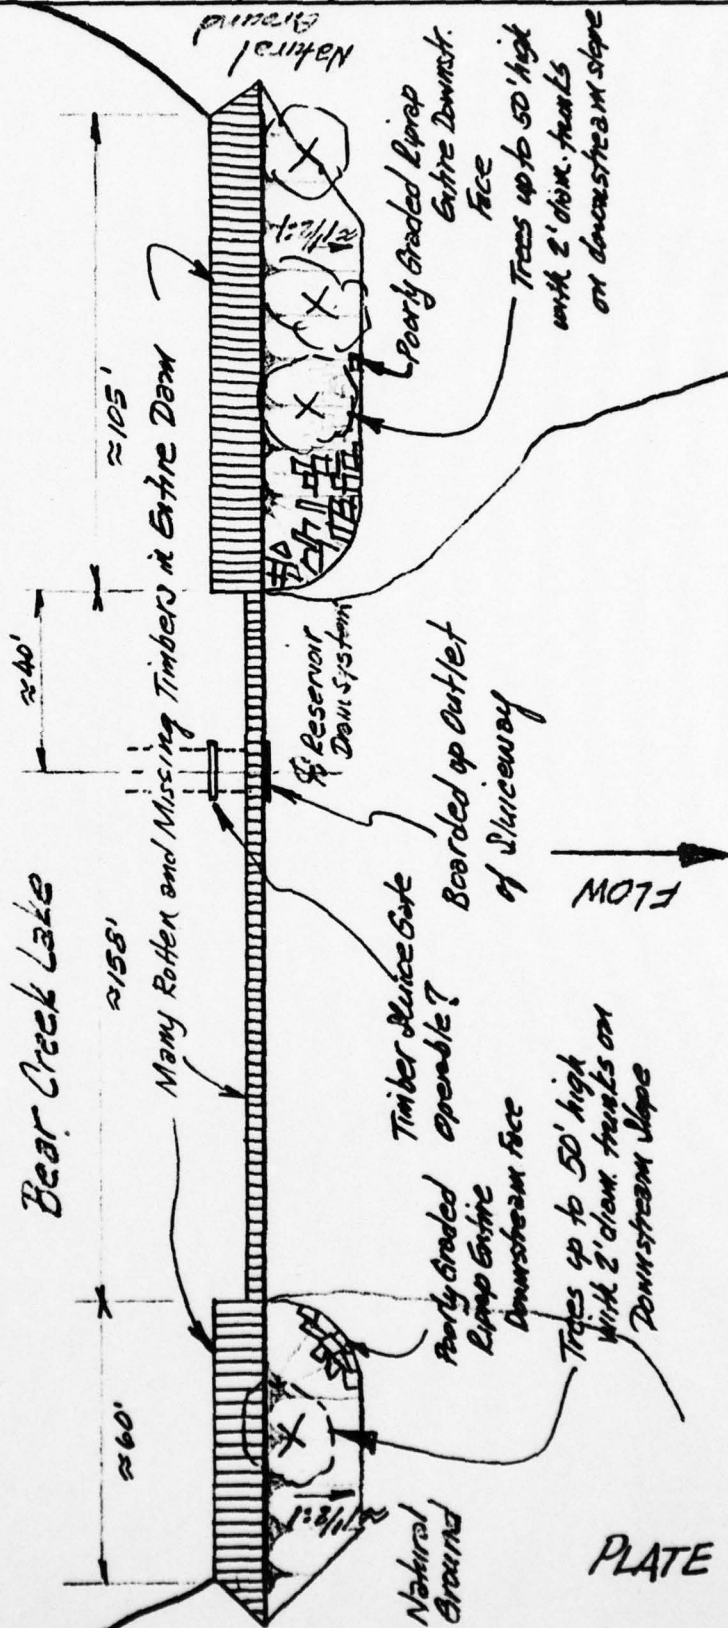
PLAN VIEW BEAR CREEK DAM AS OF 12/14/73

*Dam is of rock filled timber crib construction.*
